260-IN.-DIA MOTOR PROGRAM

FINAL REPORT
FOR MOTOR 44-SS-4

Contract NAS3-7970

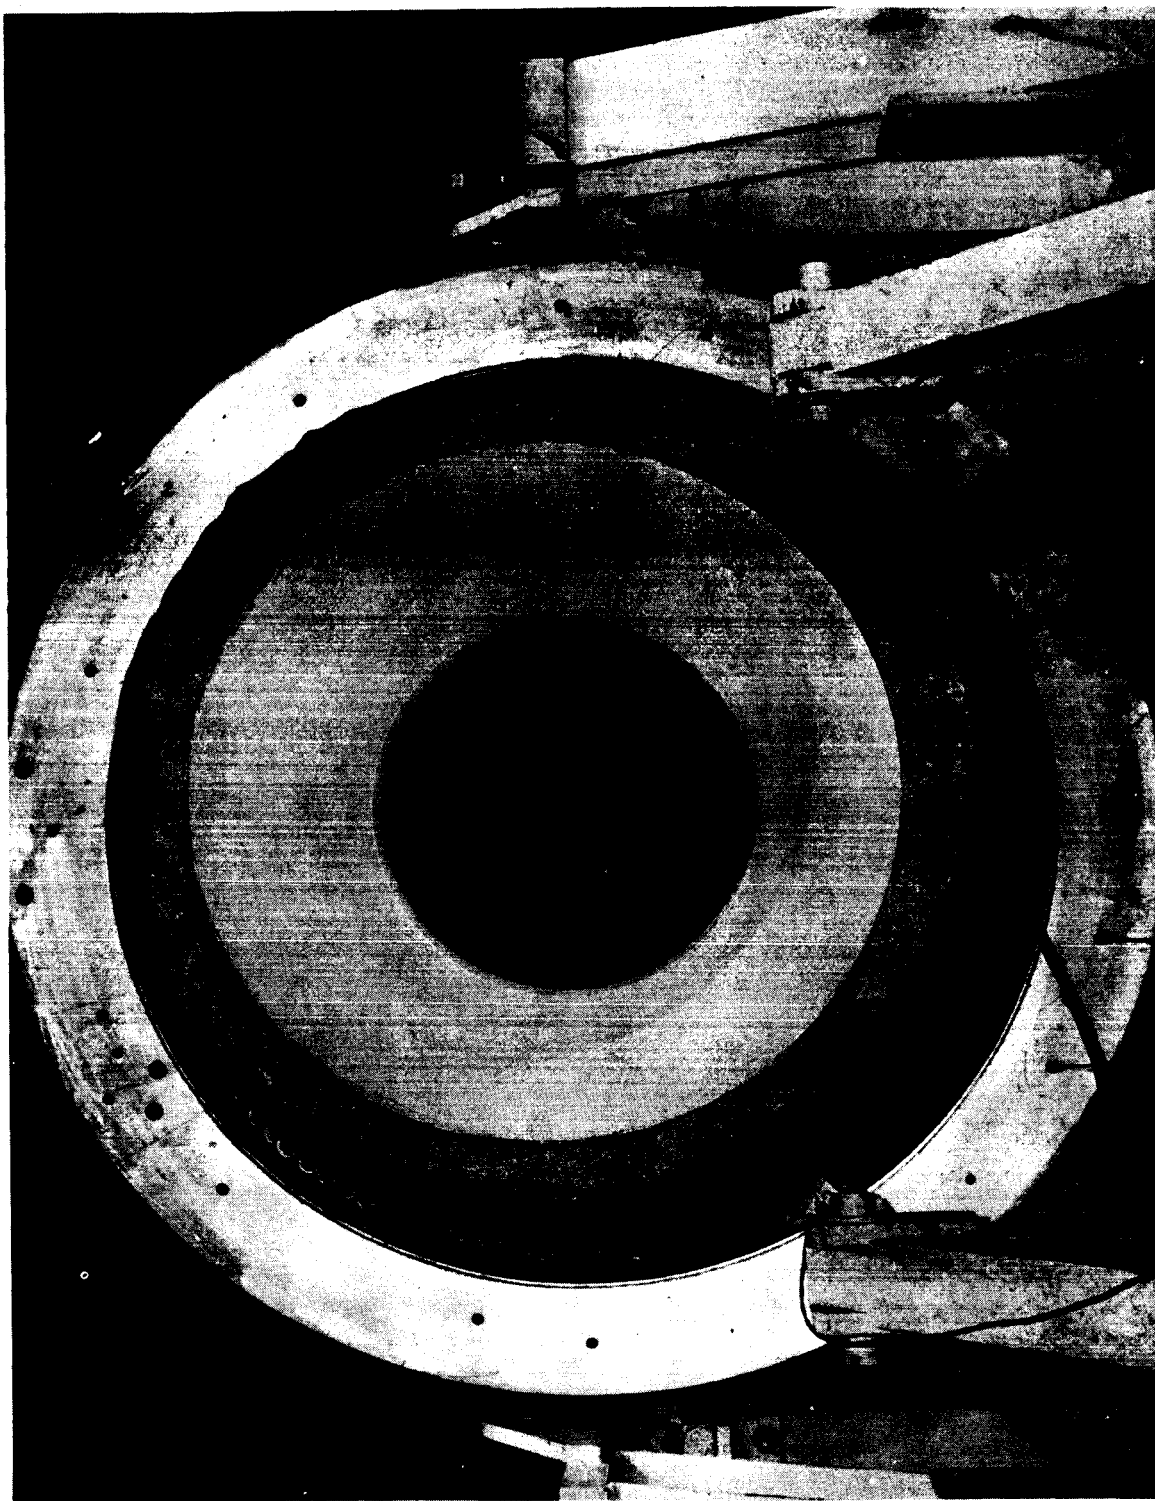
Figure 26

Prefire View of Motor 44-SS-4 Nozzle, 45° Aft

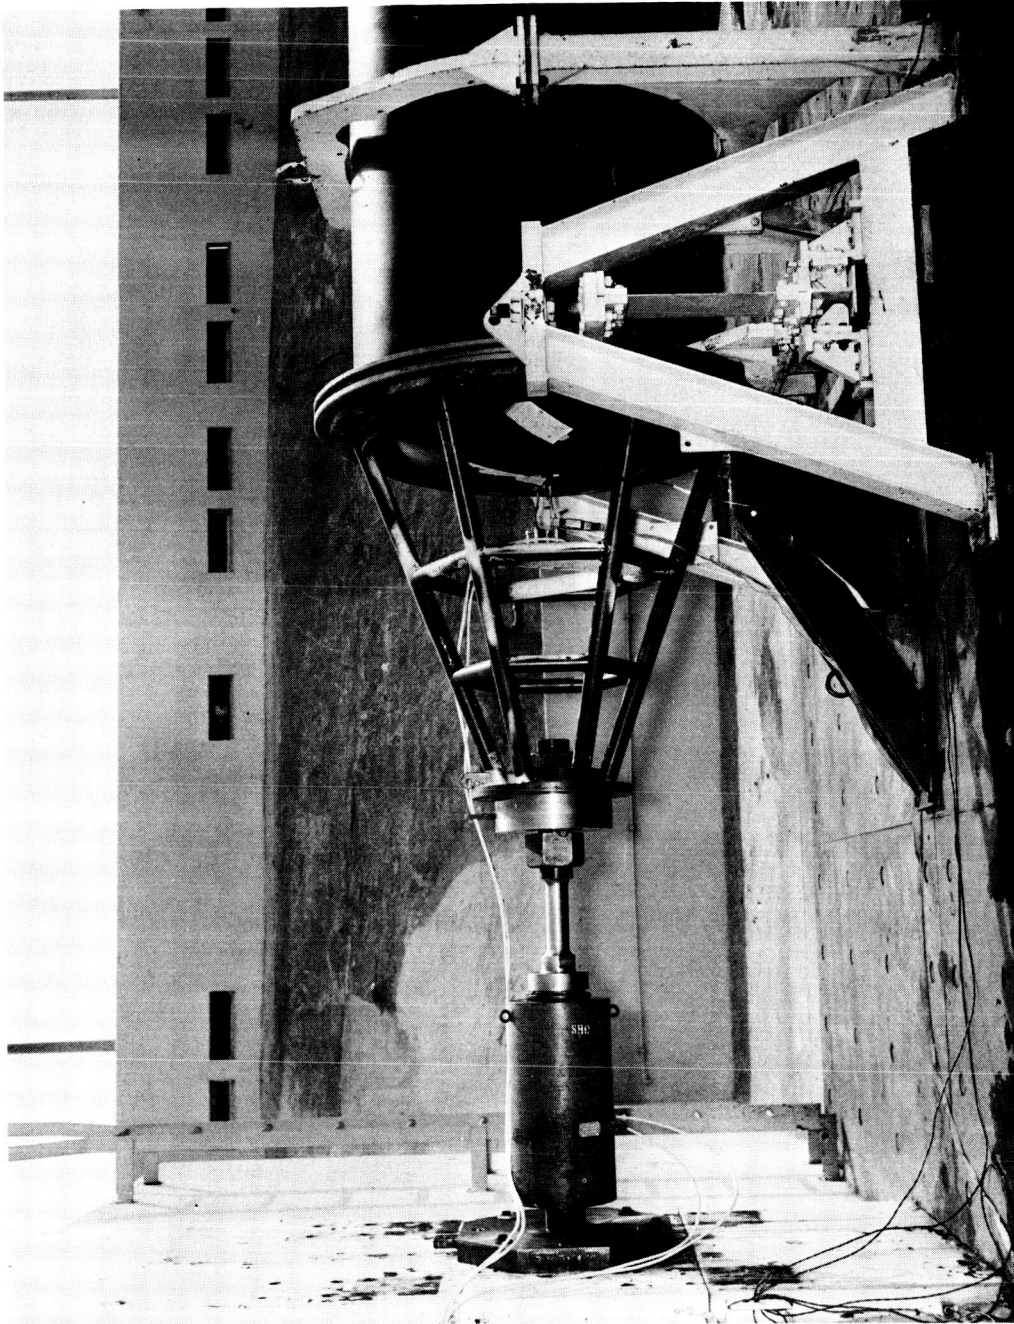
Figure 27

Test Set-Up, Thrust Measurement System and
Chamber Pressure Transducers

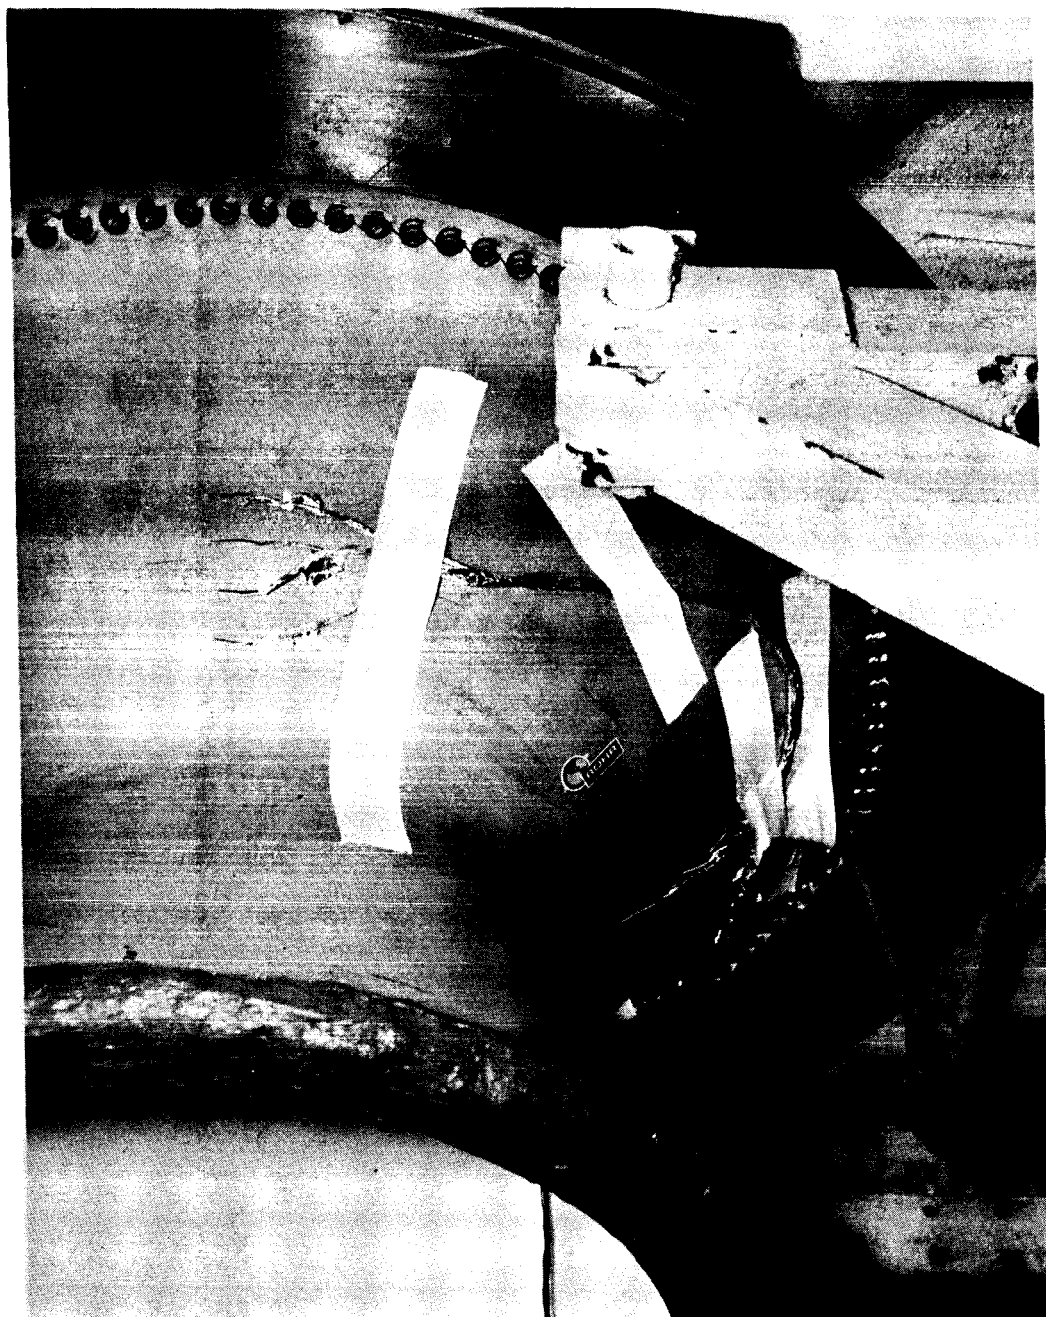
Figure 28

Typical Thermocouple Installation

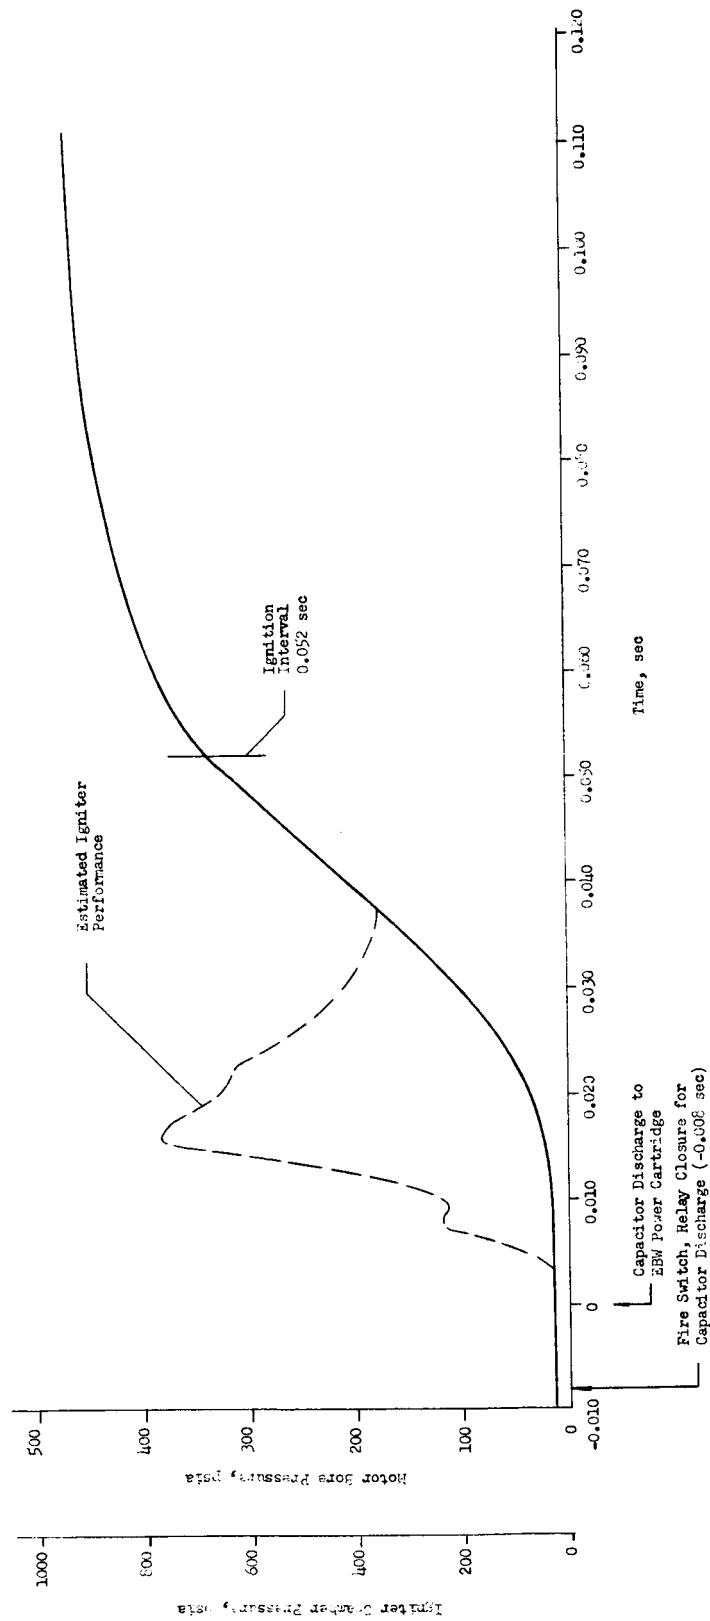
Figure 30

Ignition Transient, 44-SS-4 Static Test

Ignition of motor 44-SS-4 was satisfactory; the ignition transient is shown in Figure 30. Ignition interval occurred 0.052 sec after capacitor discharge to the EBW power cartridge. Because of the higher than required available igniter energy and the igniter burning duration (100 millisec), a 15 psi overpressure occurred for approximately 40 millisec after the motor attained initial steady state operating pressure.

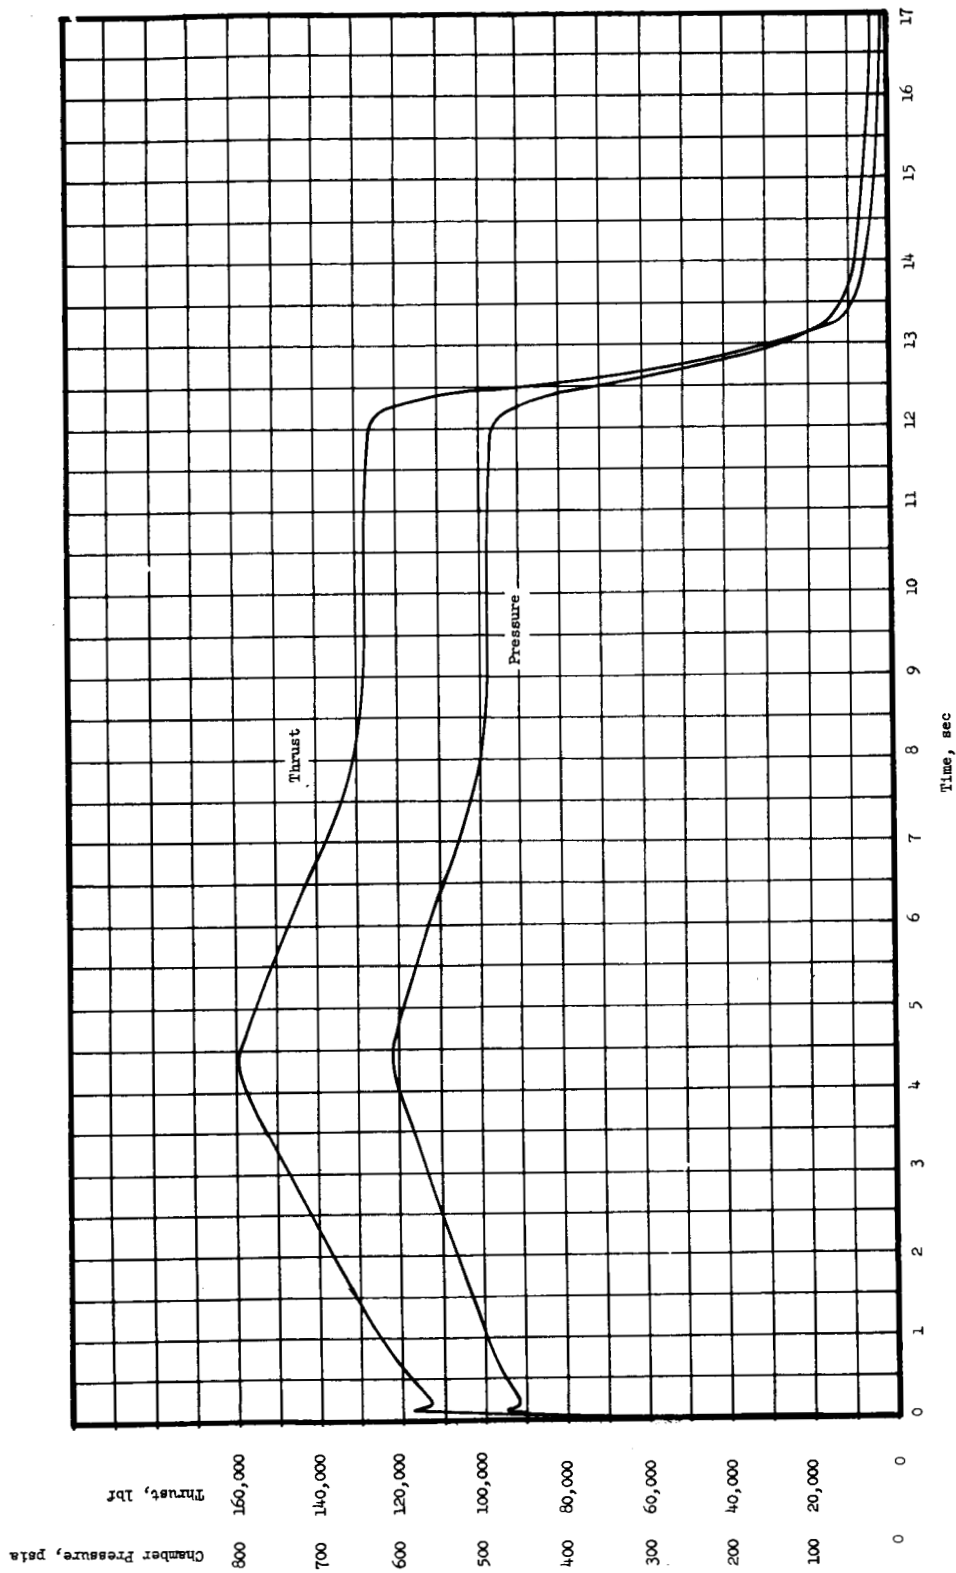
Figure 31

Pressure and Thrust vs Time Curves, Motor 44-SS-4

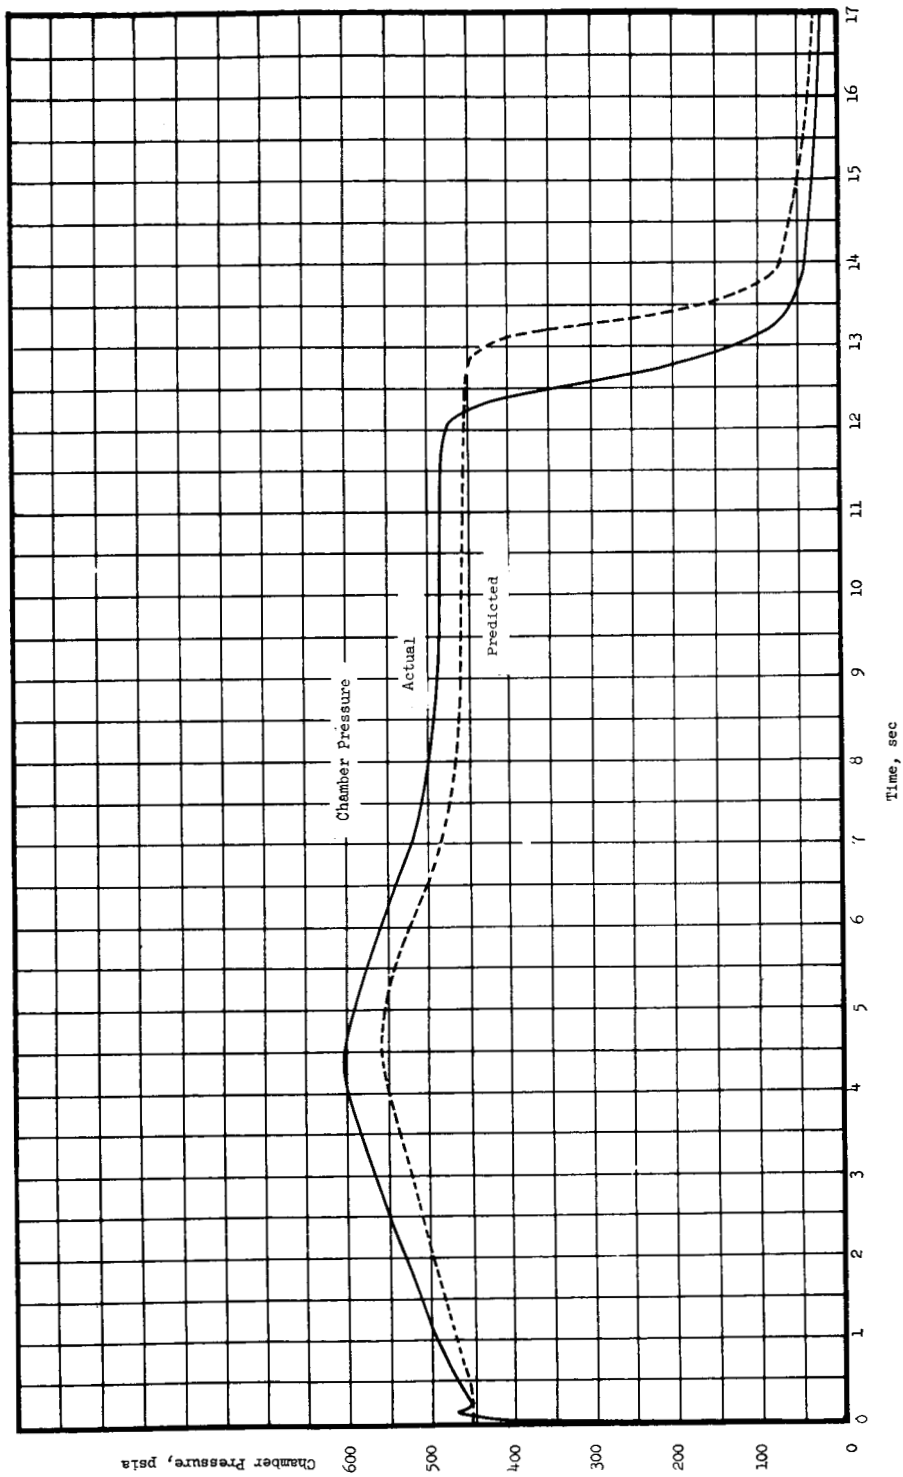
Figure 33

Predicted and Actual Pressure vs Time Curves, Motor 44-SS-4

The shape of the actual and predicted chamber pressure-vs-time curves are very similar; however, the measured chamber pressure was higher than predicted, the actual maximum being 606 psia compared to a predicted pressure of 560 psia. This was due primarily to a propellant burning rate scale-up effect of approximately 3.6% over 3KS-500 burning rate data. The standard specific impulse obtained in the firing was 244.7-sec.

The comparison between the pre-firing chamber pressure-vs-time performance prediction and the actual measured pressure-vs-time curve is shown in Figure 33. While the predicted and actual curve shapes are quite similar, the actual chamber pressure was significantly higher and the web action time shorter than predicted. It is evident that the propellant burning rate in motor 44-SS-4 was somewhat higher than predicted.

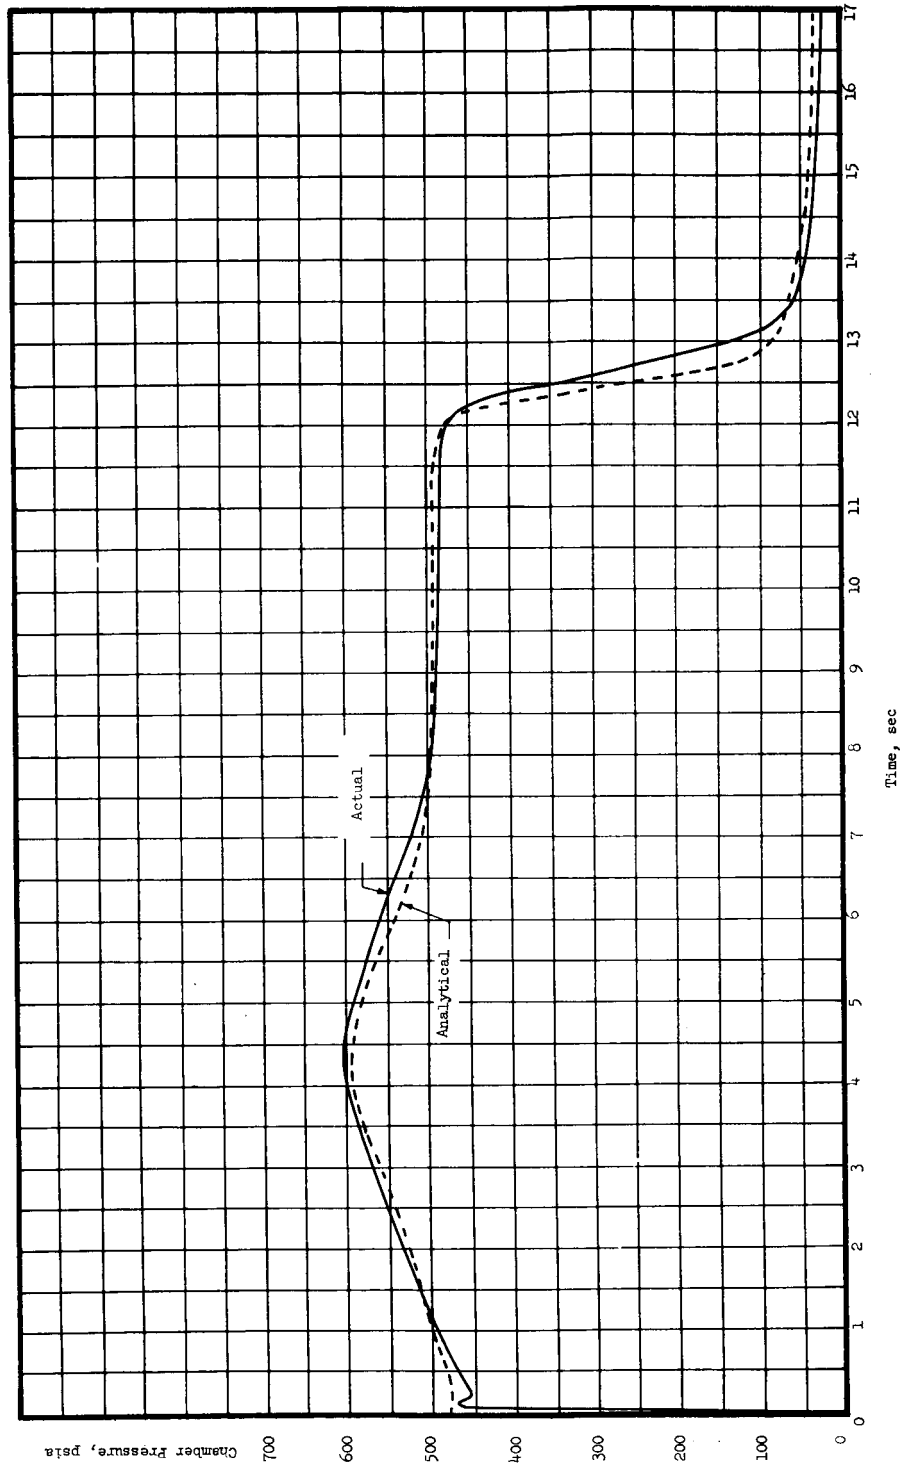
Figure 34

Analytical and Actual Pressure vs Time Curves, Motor 44-SS-4

Analysis of the motor 44-SS-4 performance indicates that the effective propellant burning rate was about 3.6% higher than that used in the performance prediction. Subsequent to the firing, a computer performance run was made using a burning rate 3.6% higher than was applied in the predicted performance calculations. The resulting pressure-vs-time curve is shown in Figure 34, compared with the actual measured pressure for motor 44-SS-4. The analytical result, using the adjusted burning rate information is in close agreement with the actual motor performance. The occurrence of this burning rate scale-up will be taken into account in the assessment of burning rate data from the 260-SL-3 motor propellant batches, and in the prediction of the motor 260-SL-3 performance.

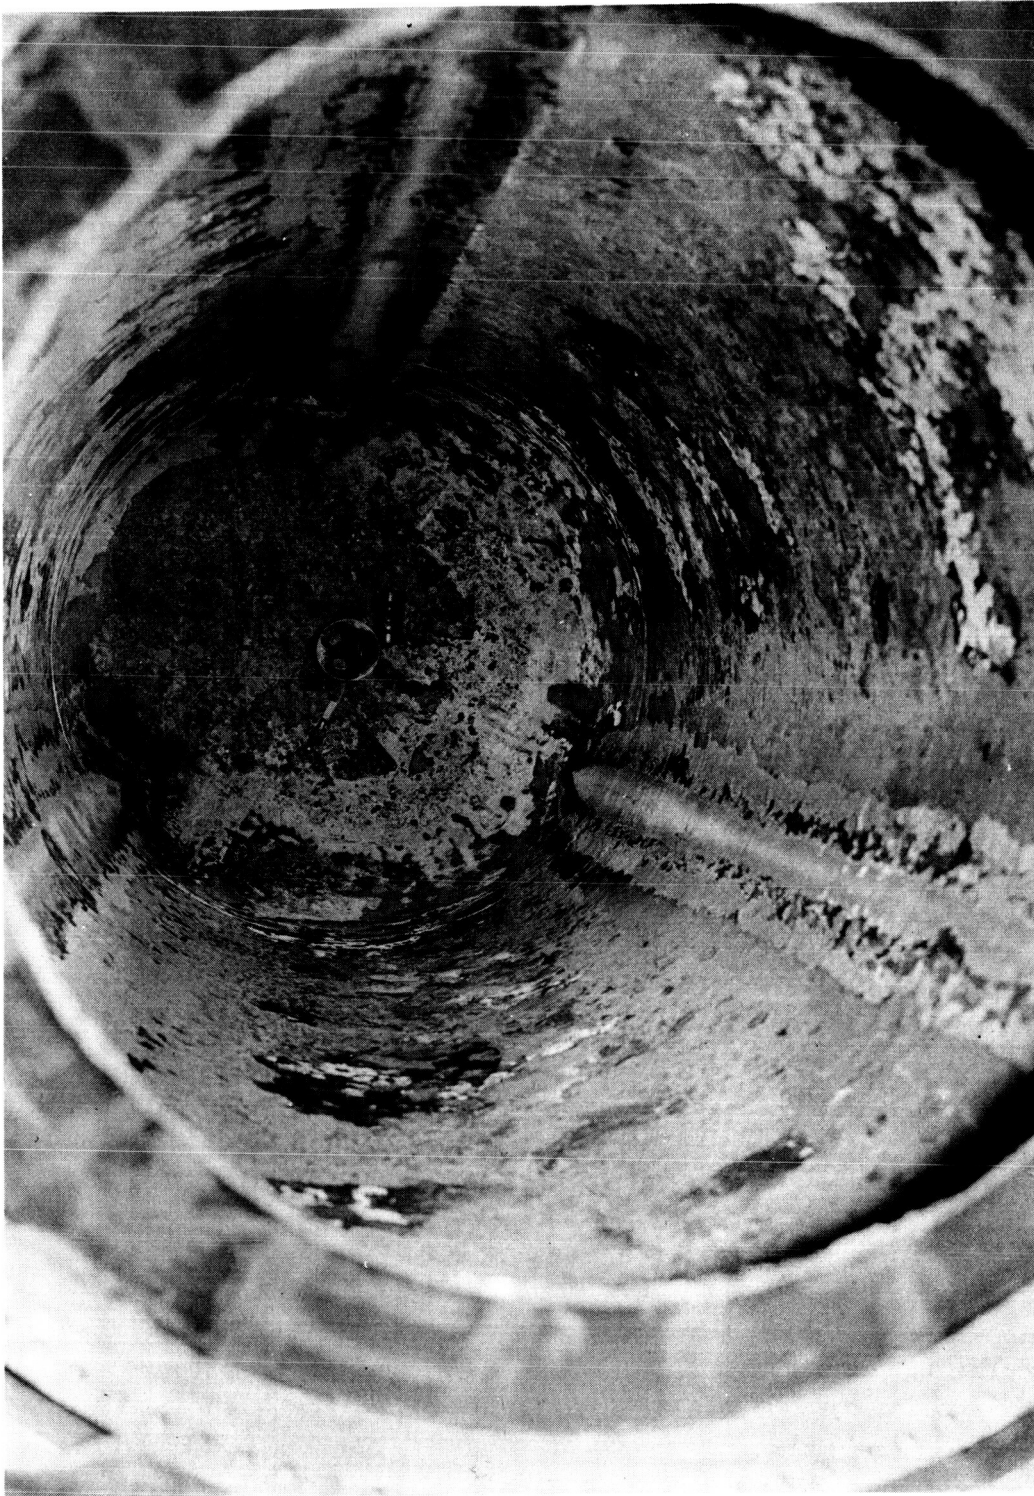
Figure 35

Posttest View of Chamber Insulation

indications of excessive erosion. Because of the short burning duration of motor 44-SS-4, no qualitative post-fire measurements were taken on the internal insulation. A visual inspection of the internal insulation revealed that the forward and aft boots were still intact and showed very little effect from heat. There were no marginal performance areas or visual discolorations on the chamber exterior. A post-fire view of the chamber interior is shown in Figure 35.

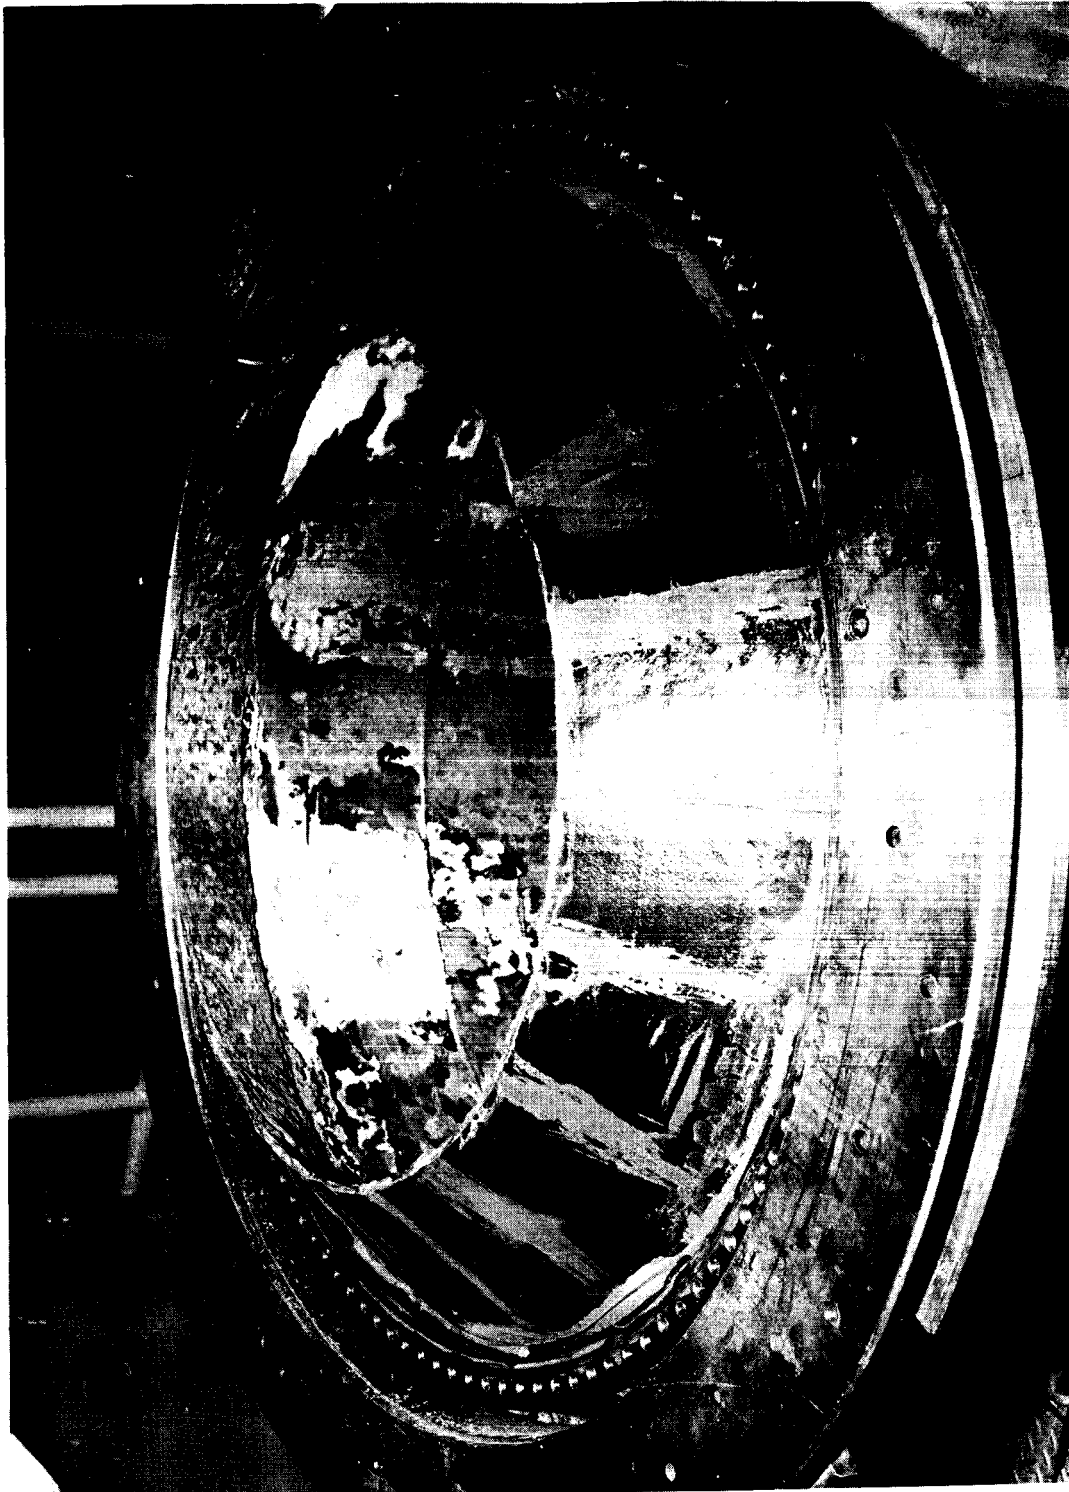
Figure 36

Posttest View of IFT-106 Grain Restrictor

As may be seen from the postfiring view (Figure 36) the IBT-106 grain restriction was in excellent condition after the test. The oscillograph record of the firing indicates that propellant-to-restriction bond integrity was maintained over the full test duration. There was no evidence of hot-gas penetration past the PR-1913-4 seal on the back side of the restriction.

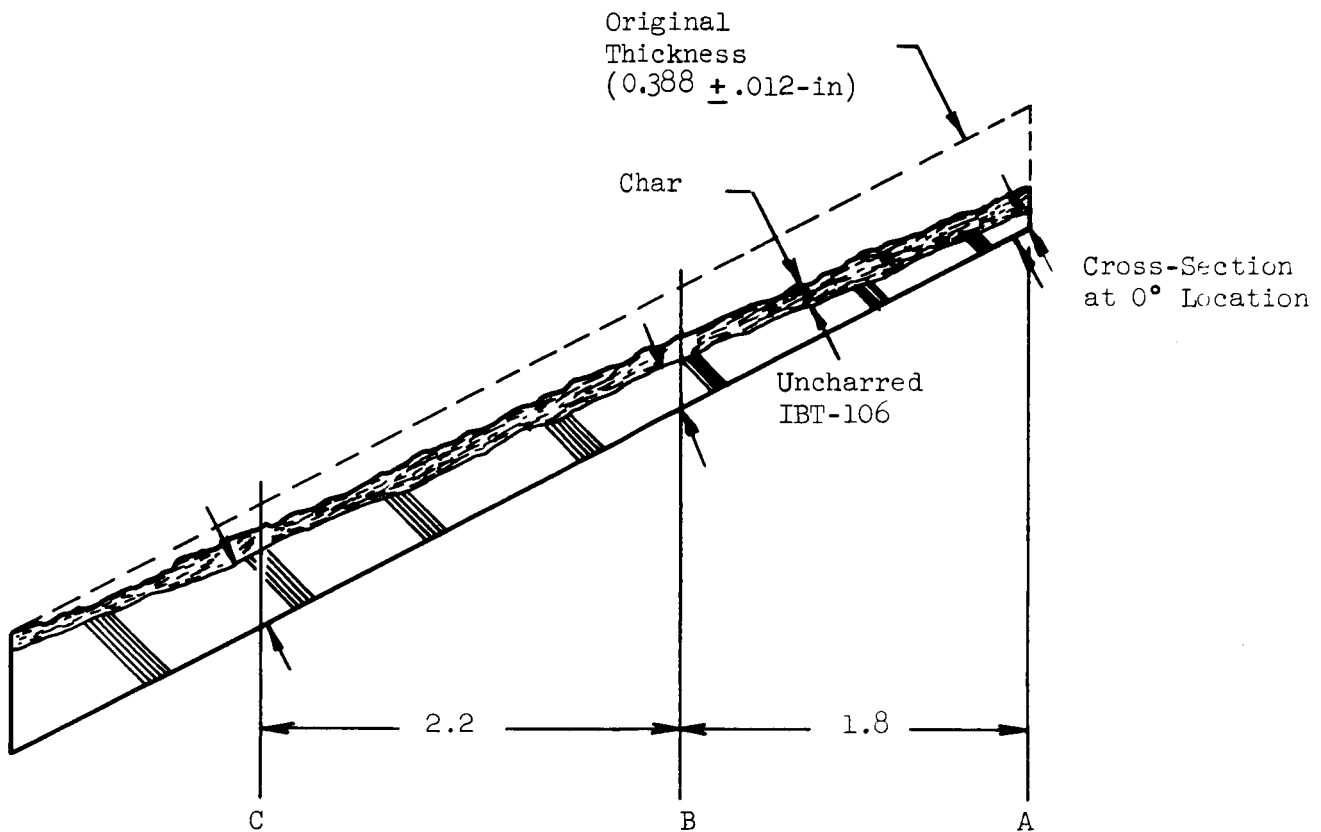
SECTION	EXPOSURE DURATION (secs)	MATERIAL LOSS (in)	LOSS RATE (in./sec)
A	12.1	.29	0.024
B	8.6	.17	0.020
C	4.3	.10	0.023

Performance of IBT-106 Restriction at Location of Maximum Erosion

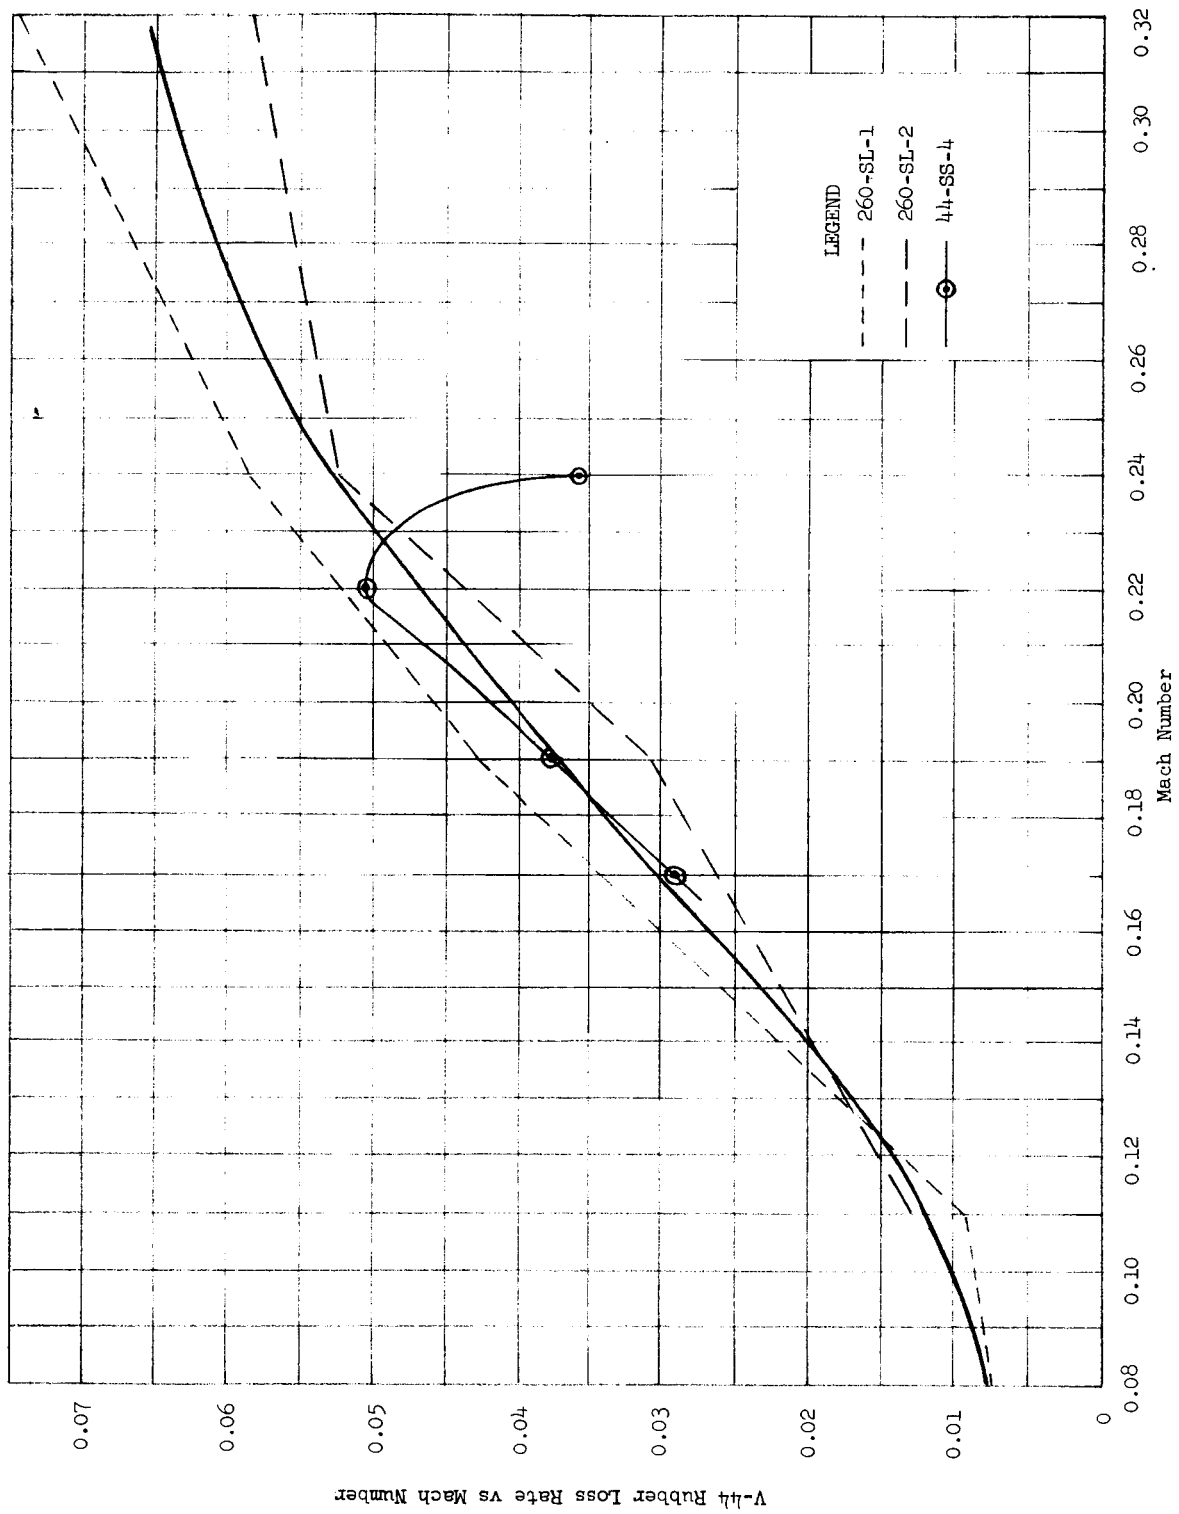
Figure 39

V-44 Rubber Loss Rate vs Mach Number

The observed thickness loss rate of V-44 rubber at this Mach number is 0.058 in./sec. Assuming an exposure time of 14 sec and a 1.25 factor of safety, the design thickness is calculated as follows:

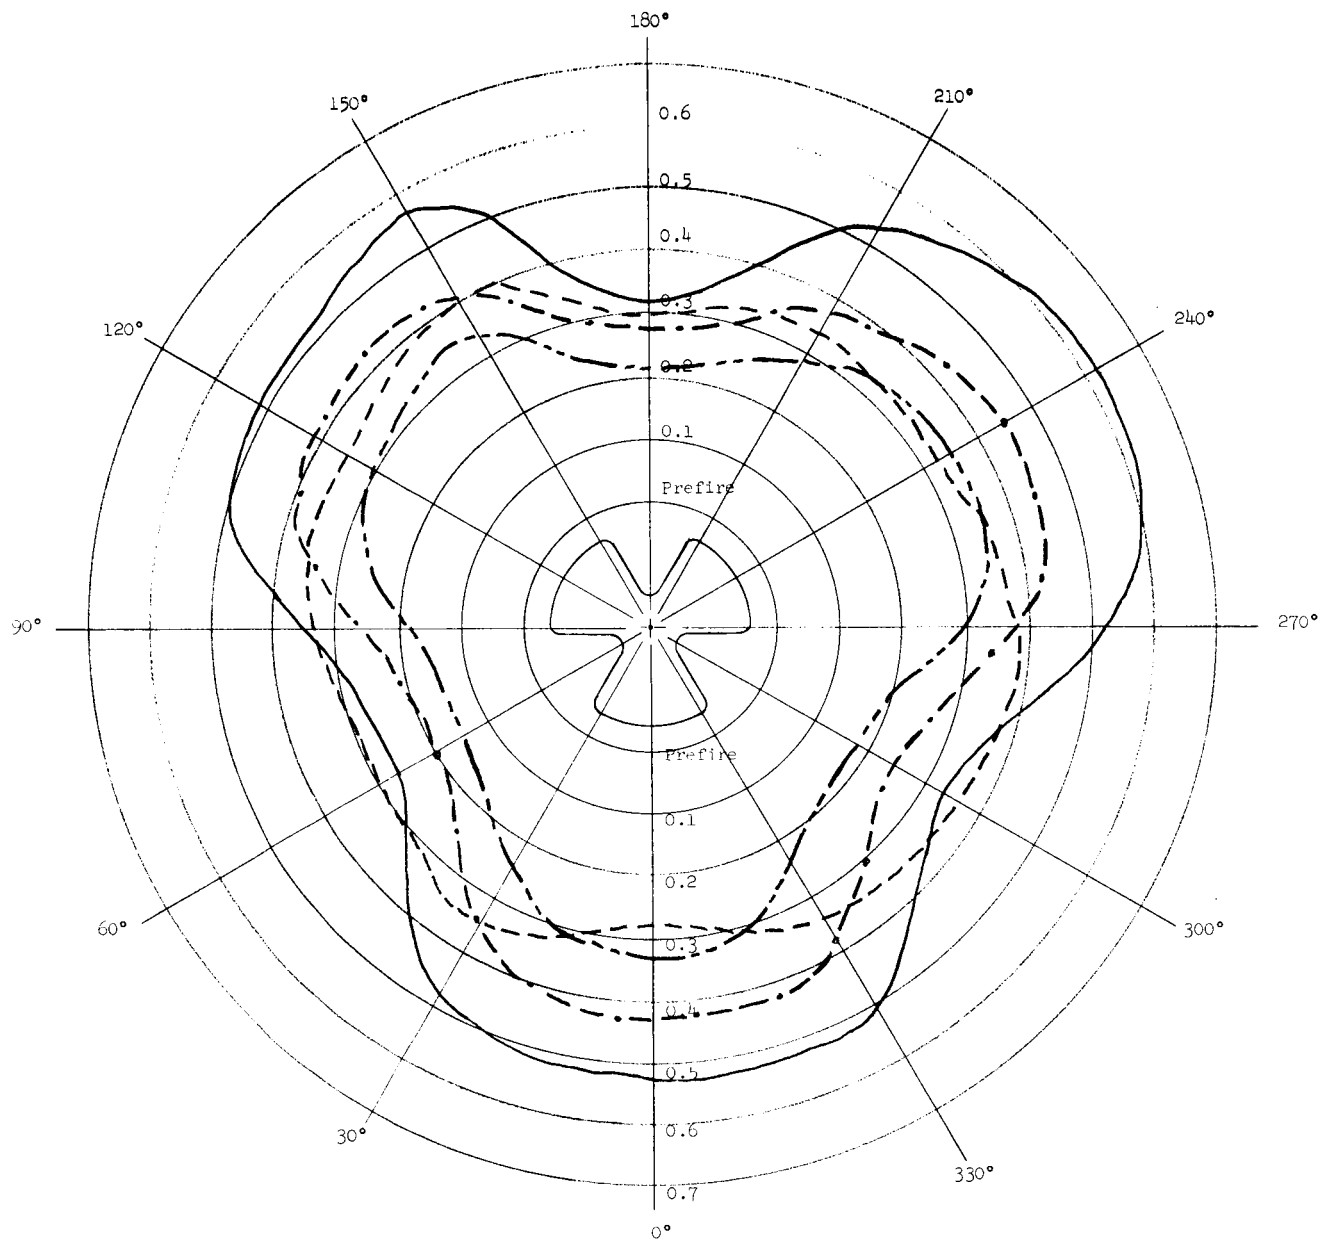
Figure 40

Station 2 - - - - -
Station 3 - - - - -
Station 4 - . - . -
Station 5 - - - - -

Nozzle Shell Insulation Erosion Pattern

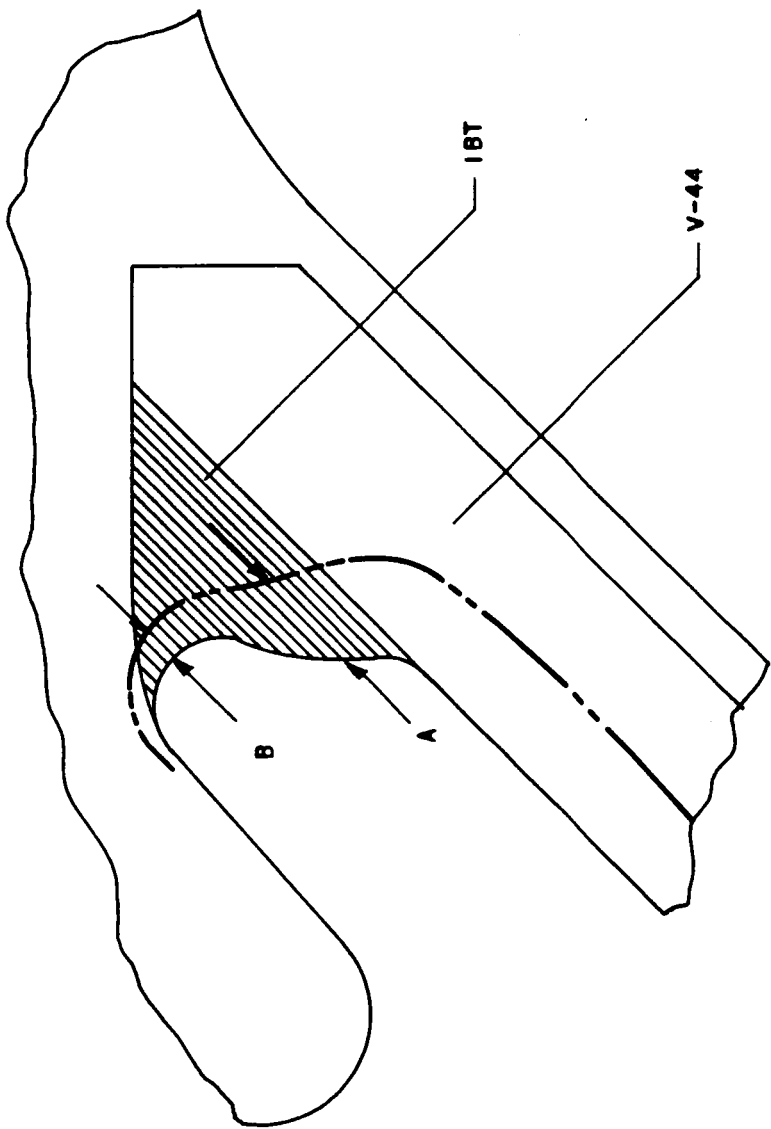
DIMENSION	LOCATION, DEGREES					
	0	60	120	180	240	300
A	0.31	0.23	0.31	0.26	0.33	0.21
B	0.01	0.18	0.06	0.05	0.02	0.08

IBT-100 Material Loss Summary

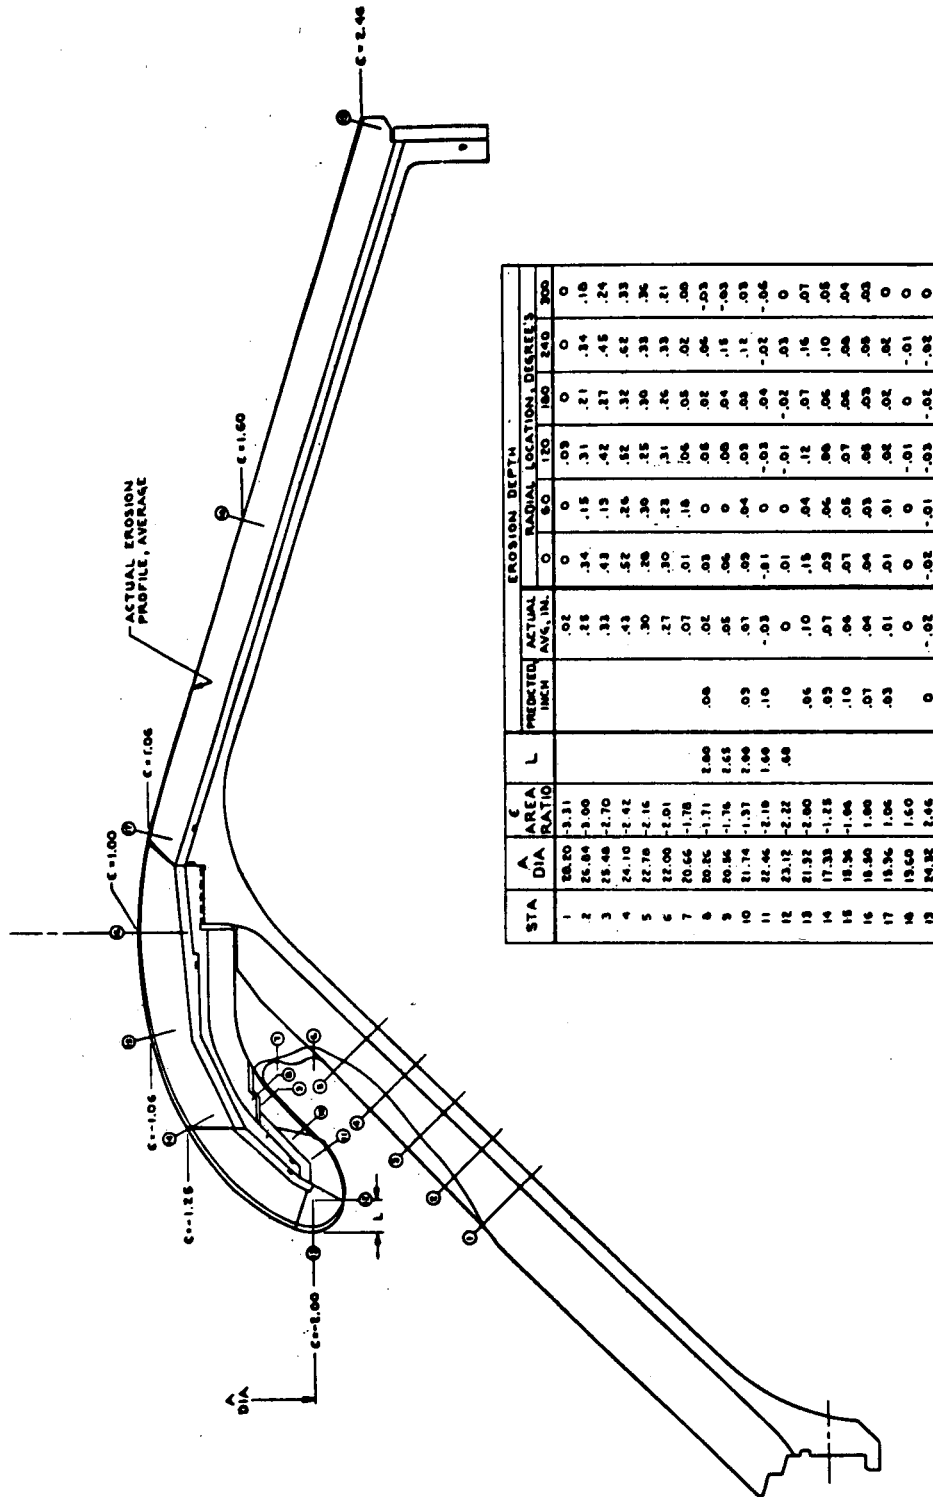
Figure 43

Nozzle Erosion Depths

The erosion performance of all nozzle materials was within design limits, which were based on twice the predicted recession depth. At the throat, the average recession depth was 0.04 compared with a predicted depth of 0.07 in. At all other stations of the nozzle, except the nose station, the average recession depths were lower than predicted. The probable cause for the overprediction is attributed, at least in part, to a net growth within the char layer of the material. This growth is confirmed by posttest measurements which indicated that negative erosion, or material growth existed in the carbon cloth portion of the submerged insert and in the nozzle expansion section between area ratios of 1.60 and 2.46. The physical explanation of this phenomenon is not established, but the growth is seemingly more pronounced on lesser angles of laminate orientation as evidence from previous nozzle tests. Possible explanations for the char layer growth include high cross-ply thermal expansion exists at the char temperature, high internal pressure due to pyrolysis of gas generation, or movement due to rapid cooling at shutdown.

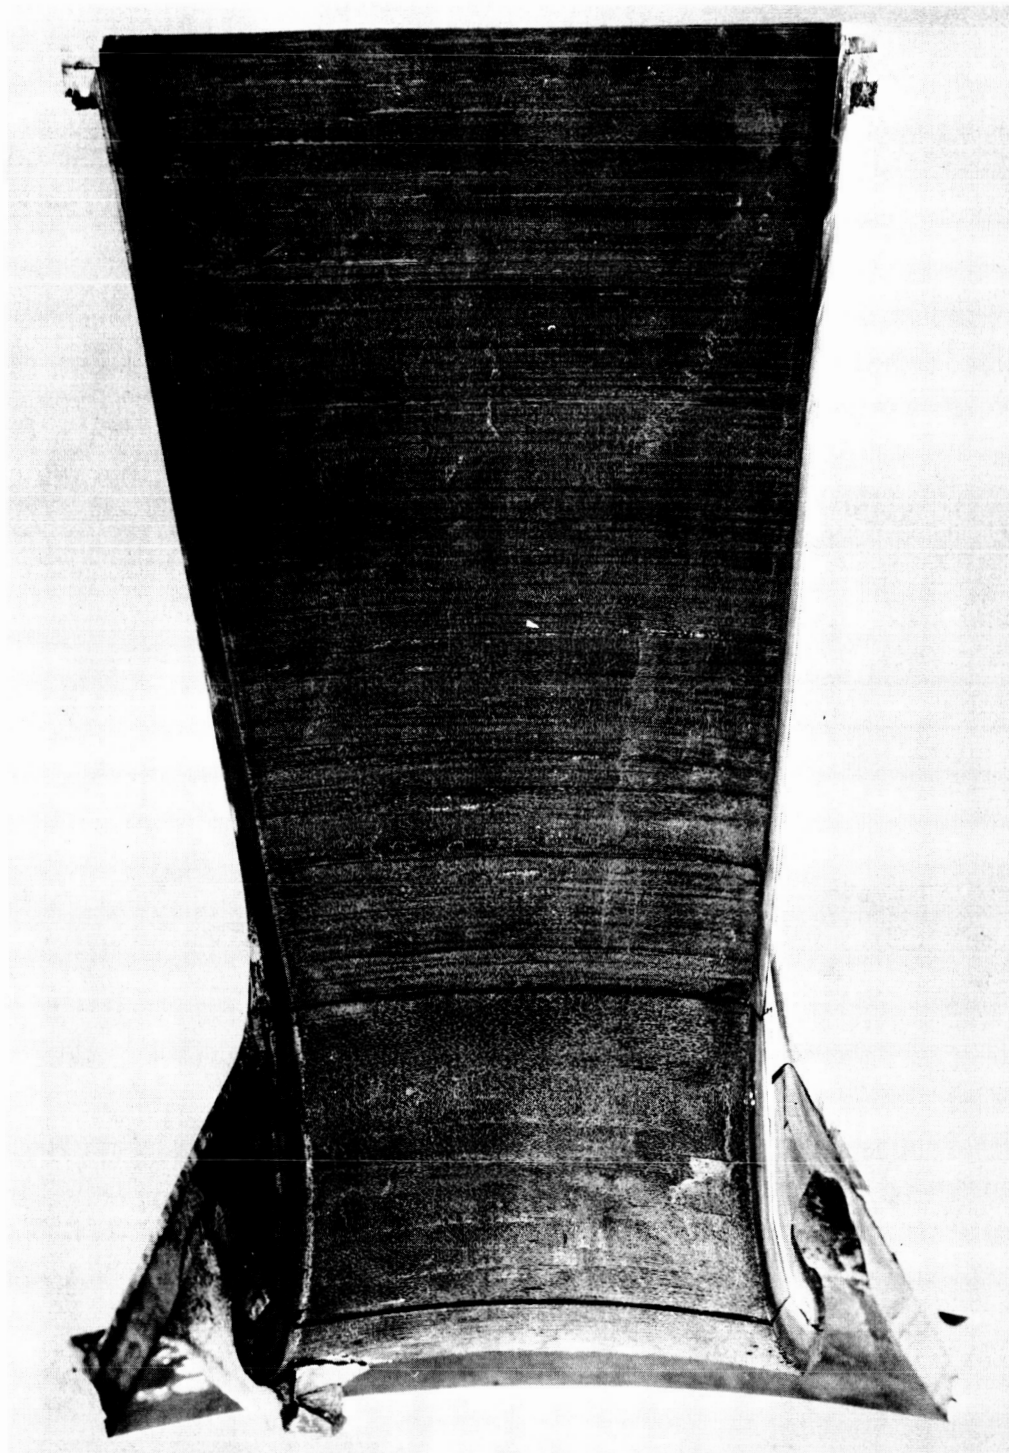
Figure 46

Posttest View of 44-SS-4 Nozzle Cross-Section

Some delaminations were observed from examination of the two cross sections of the nozzle. The majority of these delaminations cracks were found to extend only to the depth of the heat-affected zone. Those delaminations which extended to the surface of the overwrap showed no evidence of gas circulation or oxide deposit, and there was no indication of increased depth of the heat affected zone in the local area of the delamination.
